Magnesium Repair by Cold Spray

ARL-TR-4438 May 2008

V. K. Champagne, P.F. Leyman, and D. J. Helfritch Weapons and Materials Research Directorate, ARL

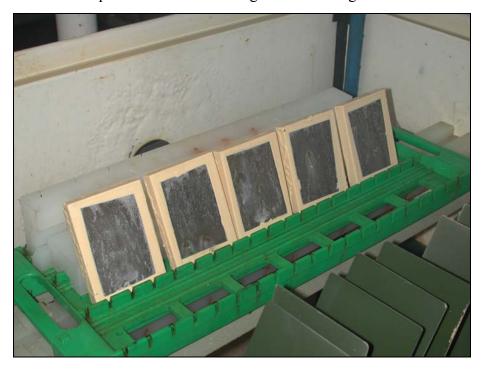
Another set of five CP-Al Mg panels were deposited using nitrogen gas at 250 °C and a pressure of 2.74 MPa. This was the highest nitrogen gas temperature that could be employed using a metal nozzle without nozzle clogging. These panels were subjected to the same salt fog spray conditions but due to the porous nature of the coating as shown in figure 11, the Al coating failed after only 8 h. The failed panels are shown in figure 15. A close-up of a resultant corrosion product protrusion from a pinhole in the Al coating is shown in figure 16.

Figure 15. Panels sprayed using 350 °C nitrogen gas after 8 h of exposure.

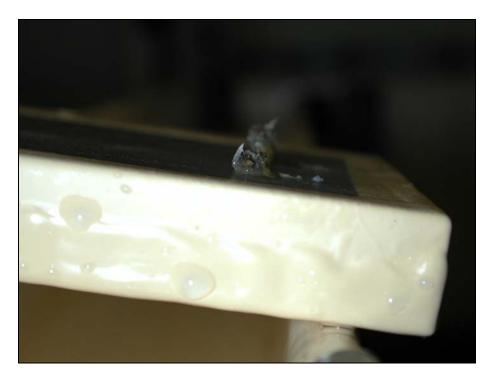
Figure 16. Corrosion product growth resulting from a pinhole in the Al coating.
